BUCK WOOD, BRADFORD Archaeological Survey Report

BUCK WOOD, THACKLEY, BRADFORD: AN ARCHAEOLOGICAL SURVEY

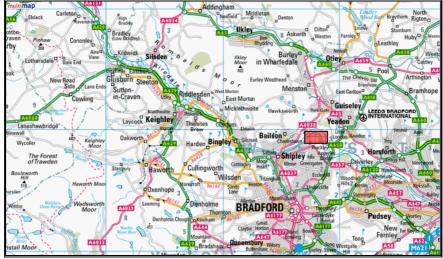
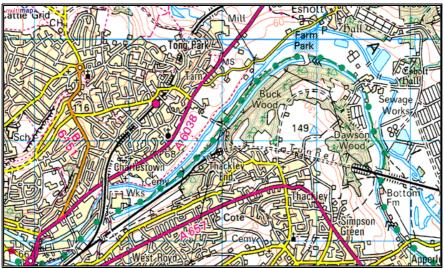
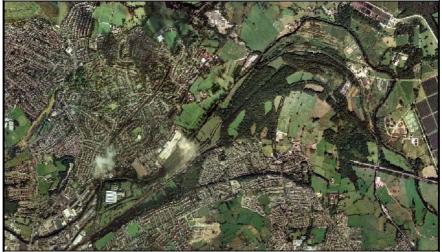
Figure 1: Buck Wood, site location and aerial photograph

Today the wood encompasses a broad semi-circular zone overlooking a marked bend of the River Aire just to the north of the village of Thackley in West Yorkshire (Figure 1). Approaching from the west it is evident that it occupies a plateau of high ground overlooking the River Aire as well as taking in the steep north facing slope that runs down to the Leeds Liverpool canal, which forms much of the boundary of the wood for the purposes of this survey. The general altitude ranges between approximately 60m along the canal towpath, to 135m along the adjacent Ainsbury Avenue. The site comprises a mixture of habitats including broad-leaved woodland, mixed deciduous/coniferous plantation, a small marshland area within the woodland, discrete areas of semi-improved neutral horse-grazed pasture and a 'tip' area, which is atypical of the rest of the site (Wilmore 2005).

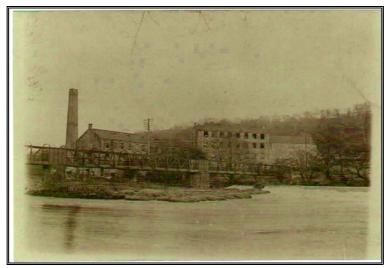
Figure 3a: Buck Mill, probably shortly after 1905

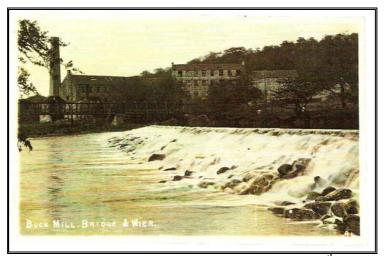
Figure 3b: Buck Mill, weir and footbridge, early 20th century

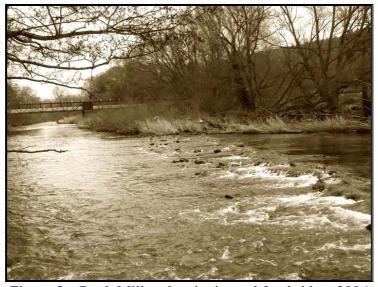
Figure 3c: Buck Mill and weir site and footbridge, 2006

Site	BW 31	
Grid reference	SE 1770 39200(centre)	
Description	Site of Buck Mill. The original mill on the site dates back to the medieval period. The visible remains are those associated with the final phase of the mill and mostly date to the 19 th and early 20 th centuries. The mill is shown as disused on an Ordnance Survey map of 1905.	
Surface cover	Brambles, shrubs, trees and stone rubble	"据" 多数
Agencies of erosion	Tipping, vandalism (potentially)	
Stability	Gradual decline	烈士
Survival	Good	20
Vulnerability	Low	
Photograph	BW31A – BW31N	
Management recommendation	Level II site. Interpretation resources to be provided. Scrub clearance of selected areas to reveal features of architectural merit. Health and safety issues to be addressed.

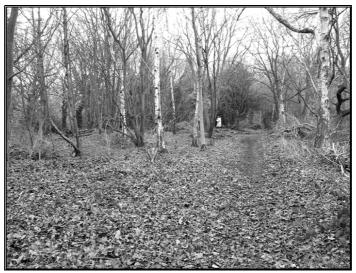
Figure 4b: The site of the Open Air School, 2006

Thackley Open Air School (BW 21), at the southern edge of the wood, was opened in 1908 for the education of the 'delicate' children of Bradford, who were mostly from impoverished circumstances and were vulnerable to a host of diseases and ailments at the turn of the 20th century. The school was founded on progressive principals originating in central and western Europe which were founded on the belief that children could thrive in an outdoor, fresh-air environment. Abandoned at the onset of the Second World War in 1939 and burned down in 1966, the remains of the school were sealed with topsoil and further obscured by decades of woodland scrub and tree cover. Using plans of the school buildings the Friends of the Buck Wood have embarked on a scheme of scrub clearance and have revealed the concrete floor of one of the two rest sheds. This is in good condition and indicates that other remains of the school probably survive below the sealing layer of topsoil and the overburden of vegetation. The school was approached by a path running from Ainsbury Avenue to a flight of steps cut into the upcast created by the construction of Thackley railway tunnel leading to the school entrance.

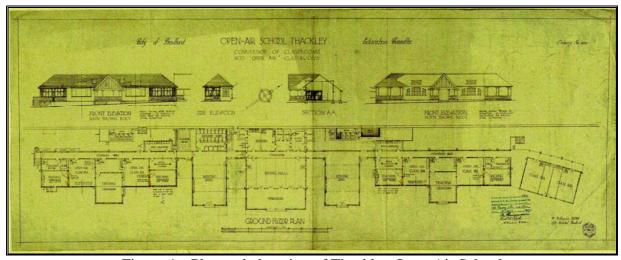
Figure 4c: Plan and elevation of Thackley Open Air School
